Insulation resisting testing on lighting circuit wiring

Application Note

Test conducted: Lighting cable
insulation resistance

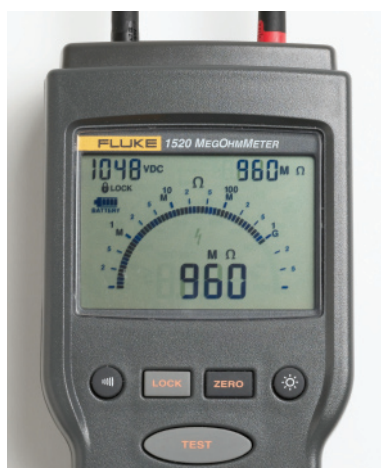
At 960 MΩ, this cable tests satisfactorily.

**"High" is relative to the specifications of the cable, the history of the installation and operating requirements. For example, the Federal Aviation Administration (FAA) requires these cables test at a minimum of 50 MΩ. Newly installed cables should show a resistance of 2 GΩ or higher.
