More snow with power quality

Application Note

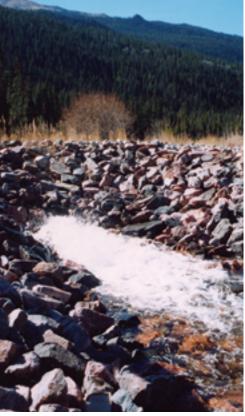
Pumped water flowing into the Snake River.
